Subj: USS MIAMI (SSN 755) FIRE PANEL RECOMMENDATIONS

**USS MIAMI (SSN 755)
Fire Review Panel**

1 October 2012

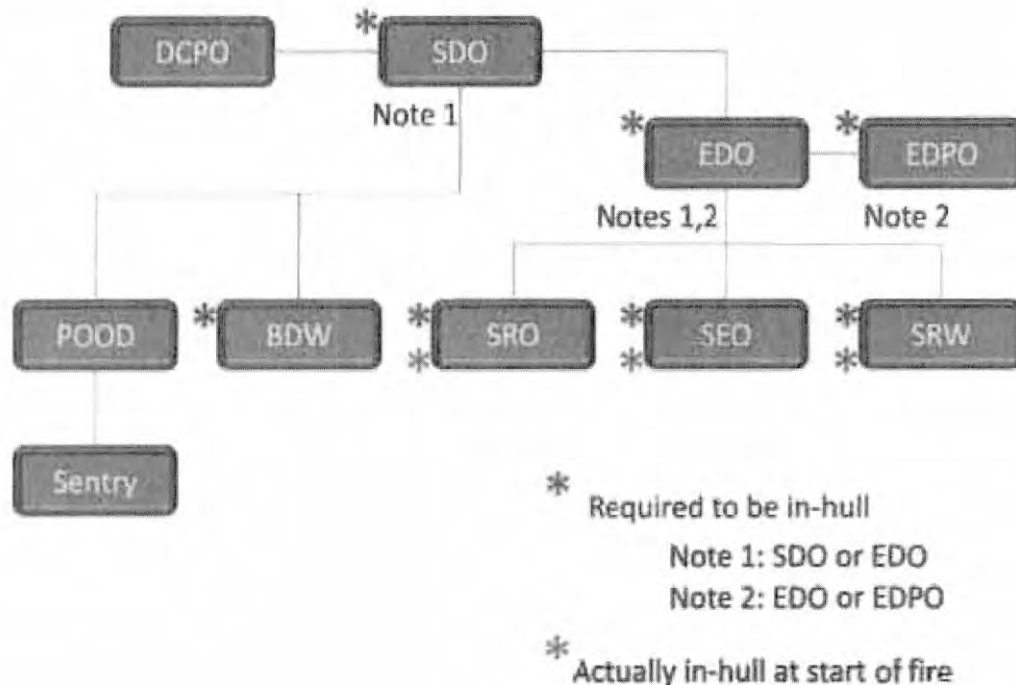
Figure 2: MIAMI In-port Watch Organization

3.1.4.1. Some allowable watchstander modifications result in reduced in-hull presence of roving watchstanders. TYCOM directives allow COs latitude on combining some non-propulsion plant watches. Some of these combinations result in roving watchstanders spending less time below decks. In an industrial environment, for periods with few or no crew members living aboard the ship, COs must carefully consider modifications that may compromise the effectiveness of the few roving watches available. Figure 2 illustrates MIAMI's in-port watch organization.

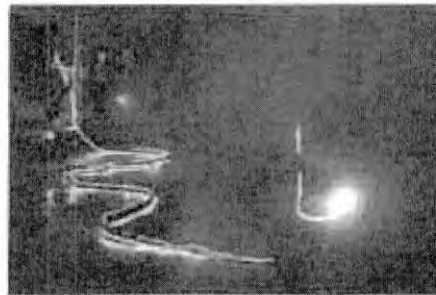
"Moonlight Hose" Utilizing Side-Light Fiber Optic Lighting System

3.3.3.4. Battle lanterns are bulky and heavy, cannot be fastened to FFEs, and provide no illumination capability in a smoke-filled compartment. Inadequate lighting was a prevalent problem in the MIAMI fire, where visibility in the FC was less than a few inches. Personnel movements, hose routing, and temporary service clearing were hampered by a lack of visibility. Traditional shipboard battle lanterns utilize dated battery and light bulb technology and provide inadequate illumination in the presence of smoke. An LED conversion alteration and improvement item (A&I N3504 for 688 class submarines, A&I N3529 for SEAWOLF class submarines) has recently been introduced to the Fleet. This modification improves illumination and reduces the weight of the battle lantern, but still utilizes the traditional bulky lantern case, which cannot be readily attached to the FFE.³⁵⁰ Readily available commercial LED products offer light weight pocket mounted or head mounted options with wavelength optimization to penetrate smoke filled atmospheres. Luminescent materials for fire hoses and fire suits allow rapid sighting capability for fire responders under reduced visibility. The Panel reviewed two Fleet mishaps between 1997 and 2007 identifying commercial LEDs used by professional firefighters as superior to shipboard options.^{351,352}

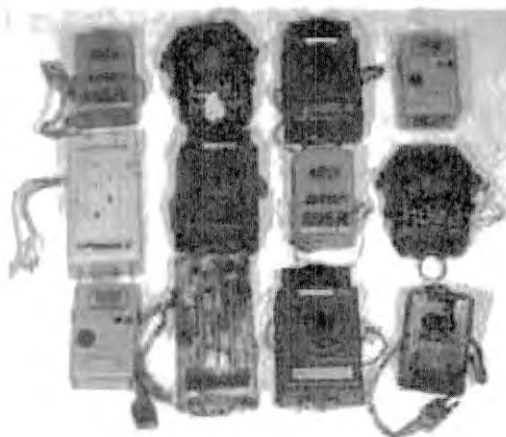
PASS devices:

- (1) Ship's force firefighters are not provided with PASS devices.³⁵⁸
- (2) PASS are commercially available and provide an audible alarm and warning when fire responders become immobilized.^{359,360}
